Service Bulletin

Bulletin No.: 18-NA-073

Subject: Repair Guidelines for Engine Component Wear

Brand:	Model:	Model Year:		VIN:		Engine:	Transmission:
		from	to	from	to		
GM Passenger Cars and Trucks		2015	2021	All	All	All	—

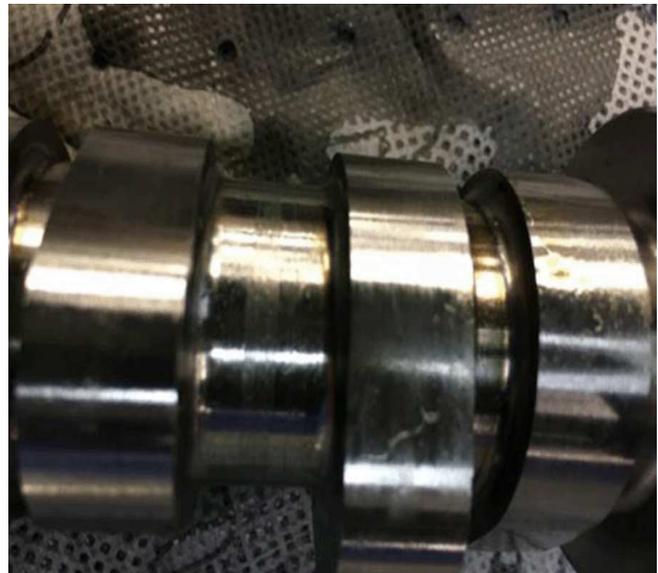
4994025

Example of minor scratching/scoring visible on camshaft lobes and/or camshaft bearing journals. In this example, the scored components can be replaced without need for engine assembly replacement.

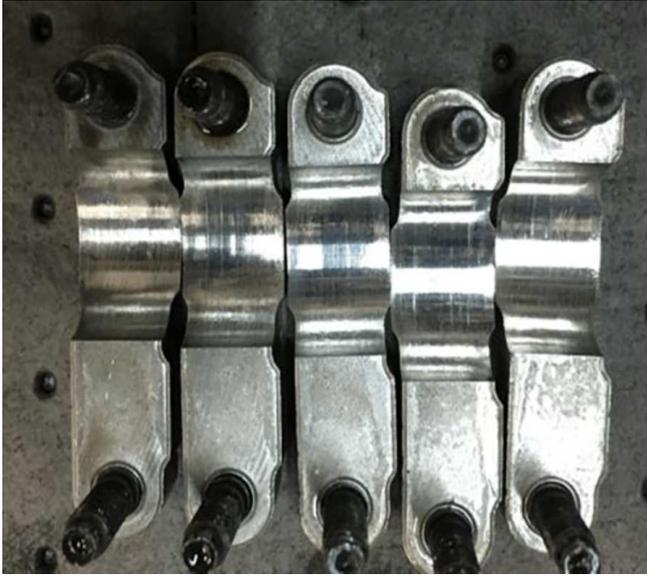
4991477

Example of minor scratching/scoring visible on camshaft bearing caps. In this example, the scored components can be replaced without need for engine assembly replacement.

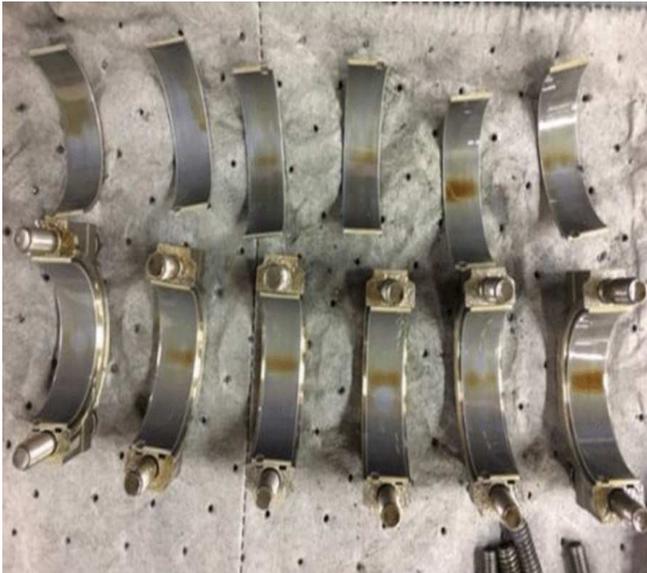
4992132

Example of minor scratching/scoring visible on connecting rod bearings. In this example, the scored components can be replaced without need for engine assembly replacement.

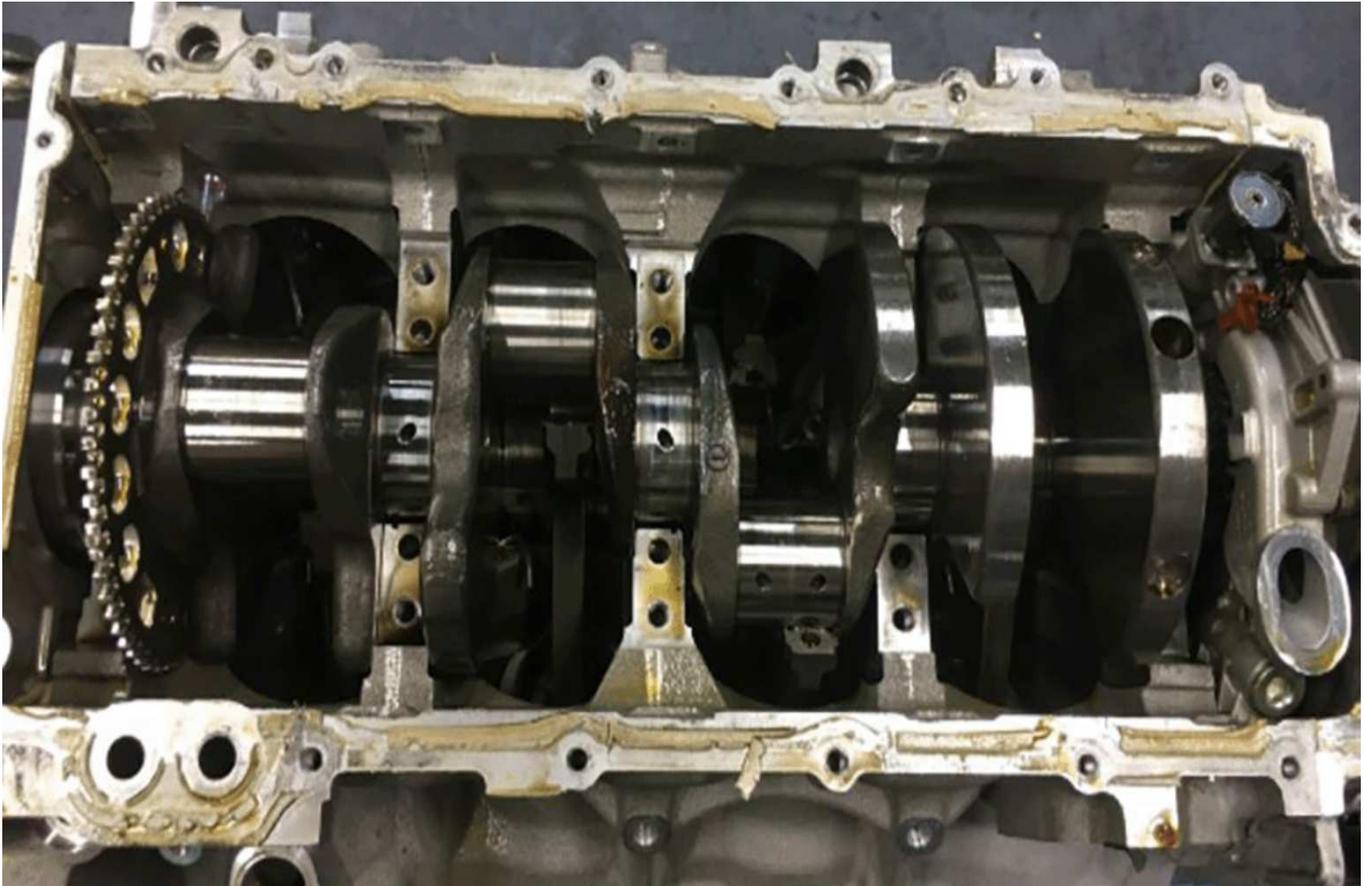
4990880

Example of minor scratching/scoring visible on crankshaft. In this example, the scored components can be replaced without need for engine assembly replacement.

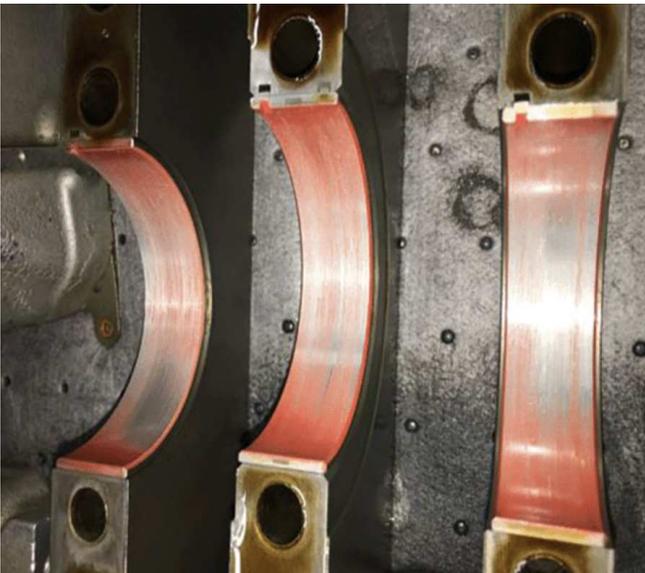
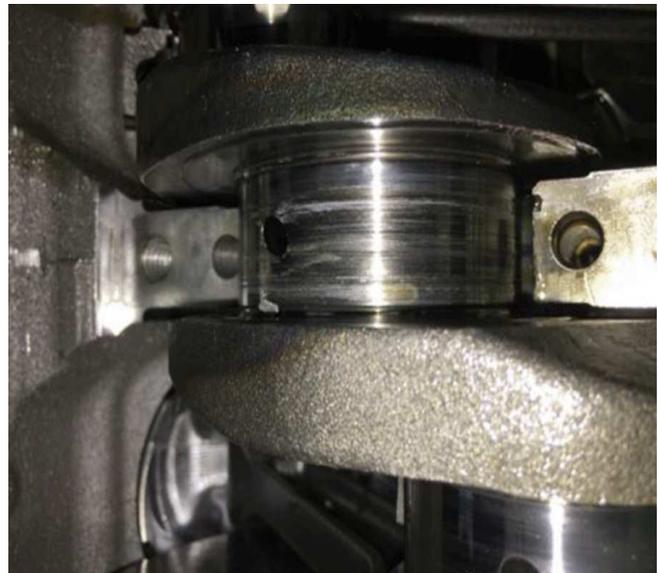
Example of minor scratching/scoring visible on crankshaft. In this example, the scored components can be replaced without need for engine assembly replacement.

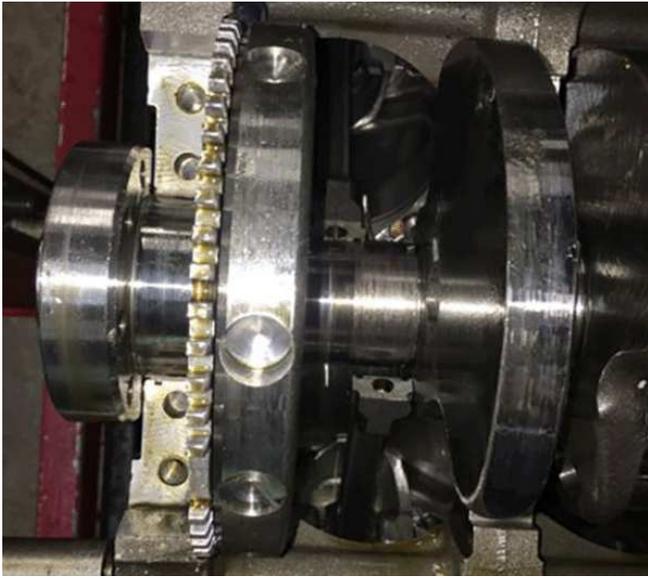
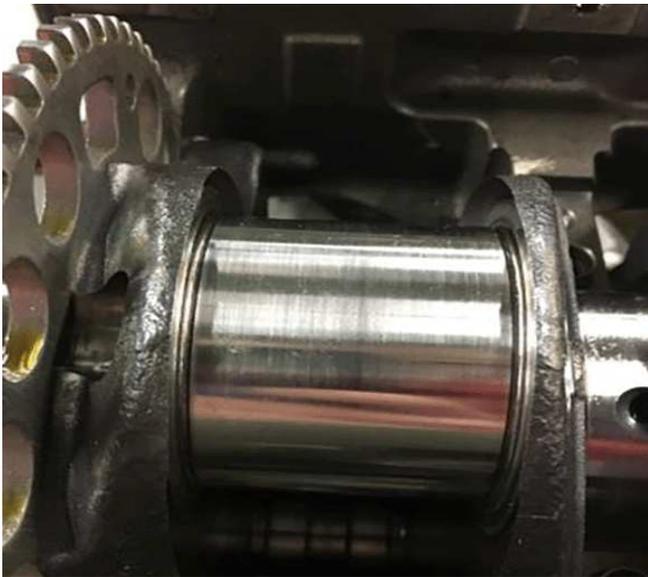
Example of minor scratching/scoring visible on crankshaft. In this example, the scored components can be replaced without need for engine assembly replacement.

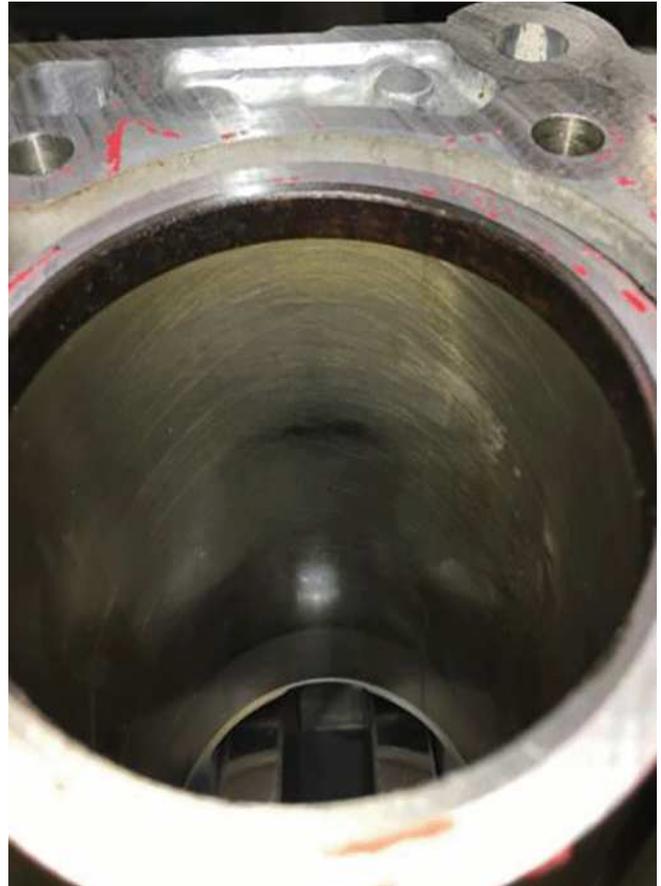
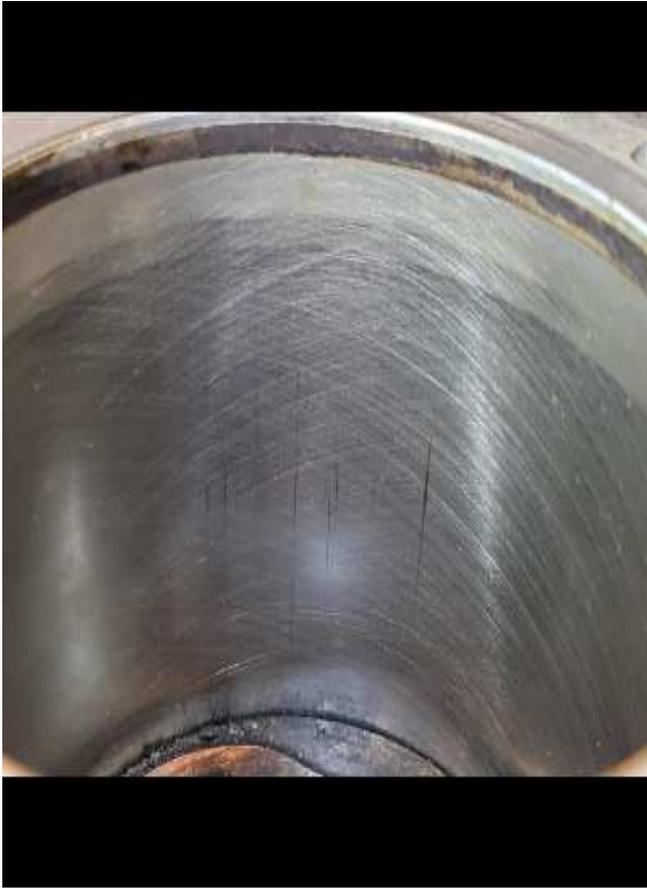
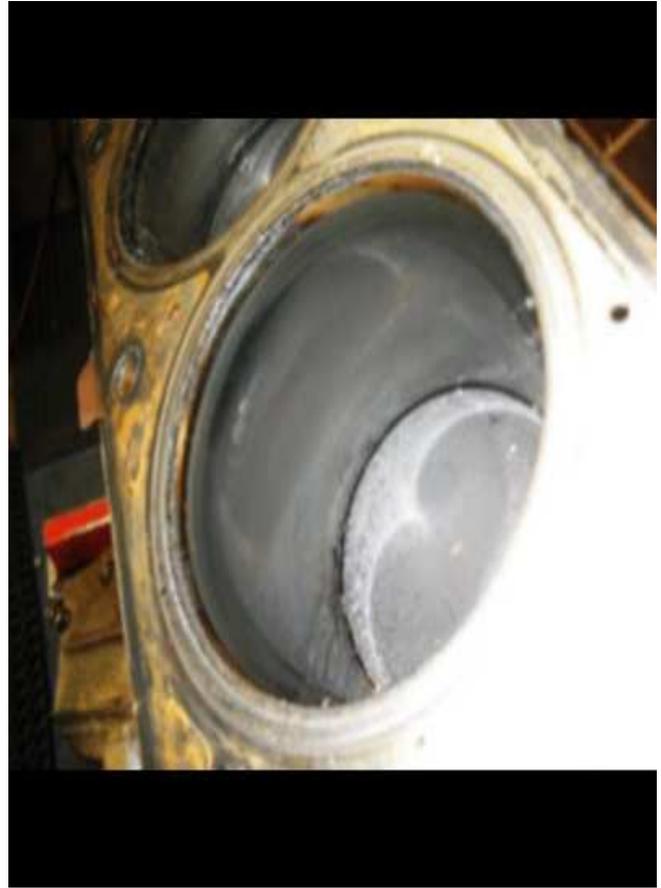
Example of minor scratching/scoring visible on cylinder wall. In this example, if you cannot catch a toothpick or fingernail on the scratch, the cylinder bore/engine block does not require replacement. If the piston is slightly scored, the scored piston can be replaced without need for engine assembly replacement (additional reference: PIP5163E).

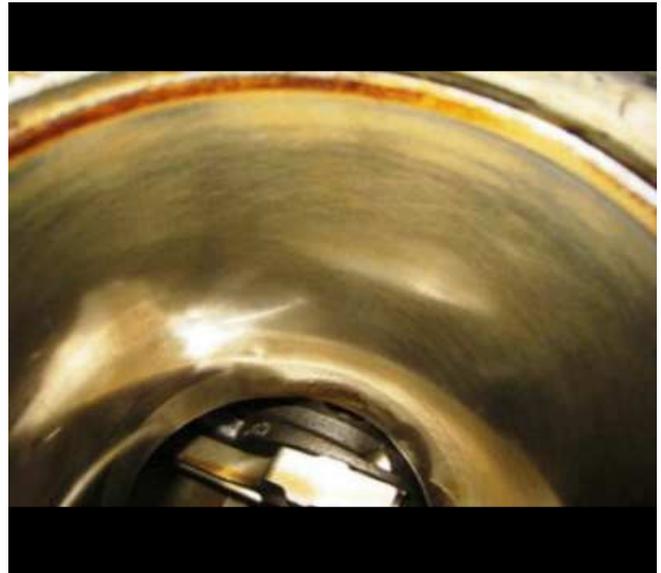
5788571

Suspecting an engine block of possible cylinder bore damage, scoring or out of round as the possible cause of engine oil consumption, misfire, cylinder leakage or blow by.

Note: The peak to valley suspecting an engine block of possible cylinder bore damage, scoring or out of round as the possible cause of engine oil consumption, misfire, cylinder leakage or blow by. spec for crosshatch is .65-2.8 microns. Any deviation and the crosshatch will be gone even if a cylinder is suspected of being oversize, we can only confirm that by checking with an air gauge at the engine plant.

1. Cylinder damage or scoring – The cylinder walls will contain grooves deep enough to catch with a fingernail.
2. Out of round cylinder bore – Contains areas where the crosshatch is missing or worn from different sections of the cylinder bore. If there is crosshatch all the way around the bore from top to bottom, the cylinder bore is not out of round.

3. Dirt intrusion – If the filtering system has been compromised, the engine will wear out very quickly. You will find grit in the intake runners and the cylinder bores will look lightly sand blasted. The crosshatch will be faint and there will not be sharpness. At high mileage this may not be Warrantable if the air filtering system has been opened numerous times for service in dusty climates.

4. Catalytic converter failure – If a converter fails and the brick is broken, the dust can be drawn back into the engine. A block showing this type of failure will have bores that look to be sand blasted. Back cylinders go first if caught early. Otherwise there will be no crosshatch and the engine will need to be replaced.

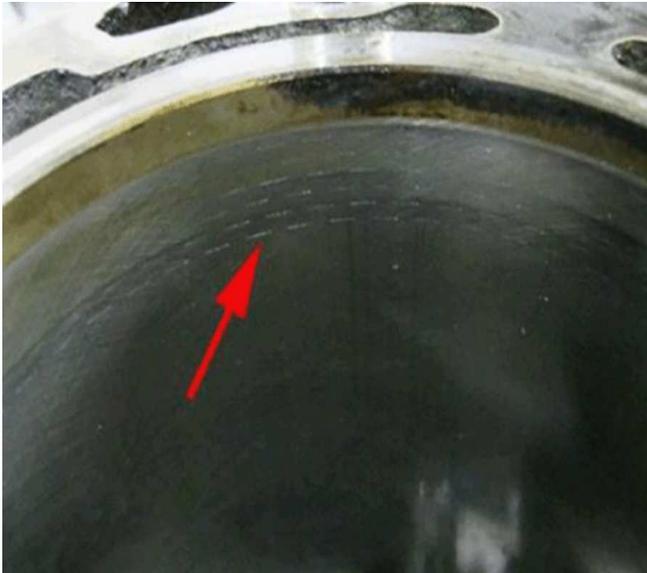
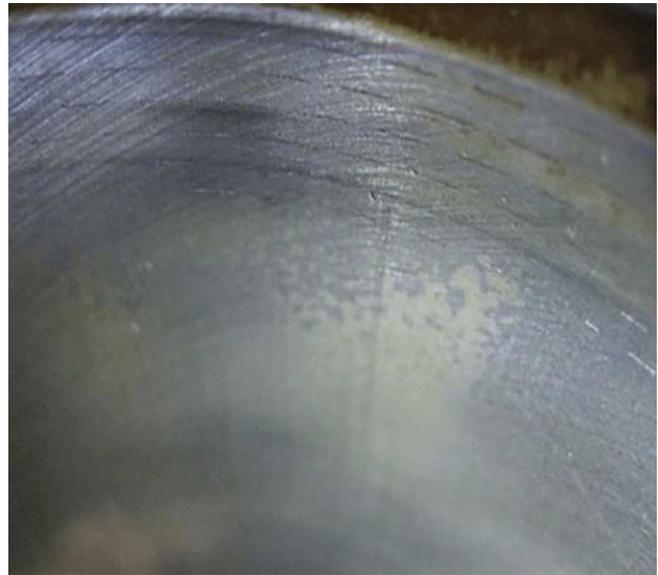
Some technicians may be replacing entire engine assemblies due to marks found at the top of the cylinder bore. These marks are considered normal and are left as a result of a manufacturing laser honing process. **DO NOT** replace the cylinder block or the engine for these normal laser honing marks (refer to PI0725B).

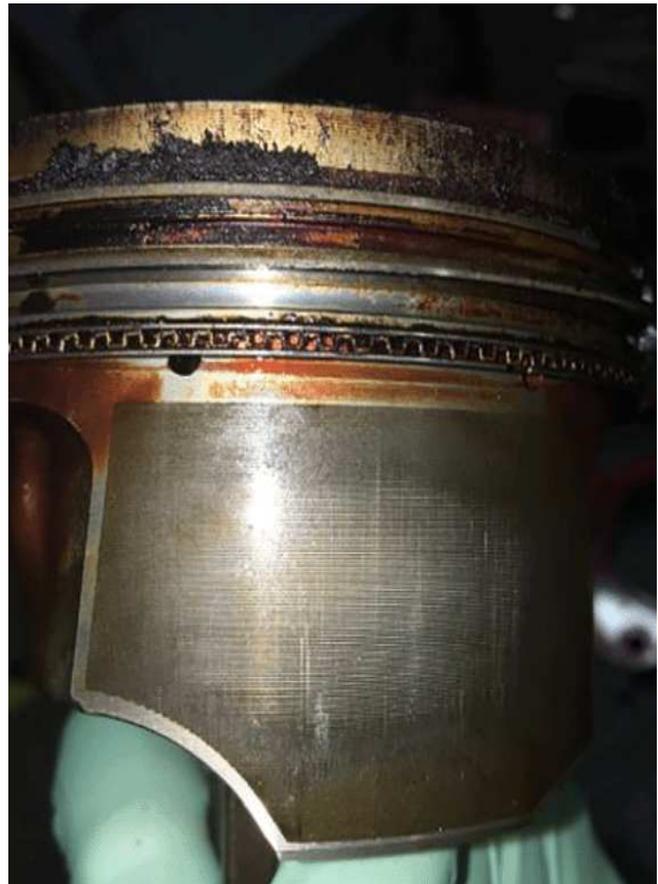
4992916

Example of minor scratching/scoring visible on piston. In this example, inspect for broken and/or stuck rings and piston ring lands and cylinder wall for damage. If no cylinder wall damage or other significant damage, components can be replaced without requiring an engine assembly replacement.

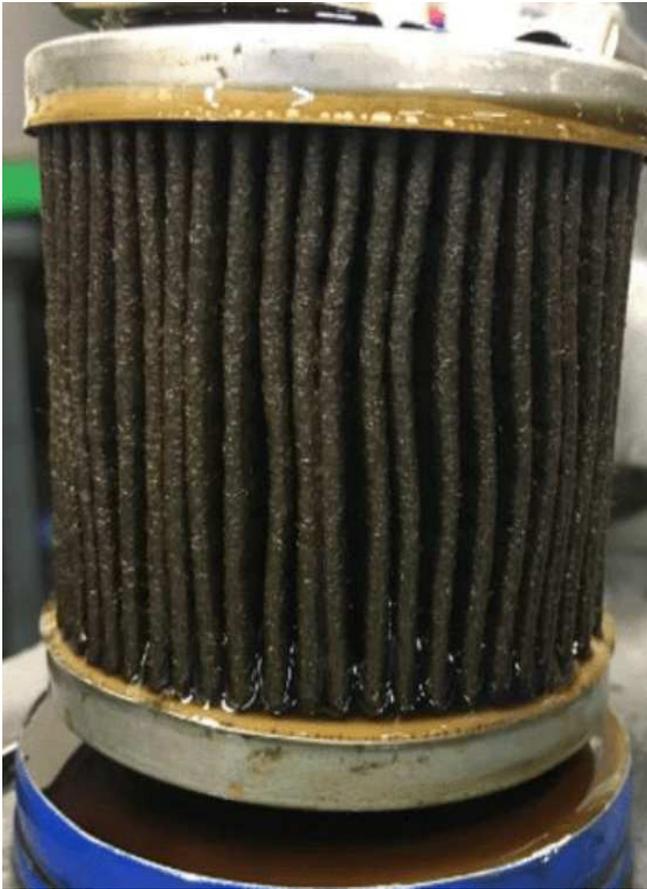
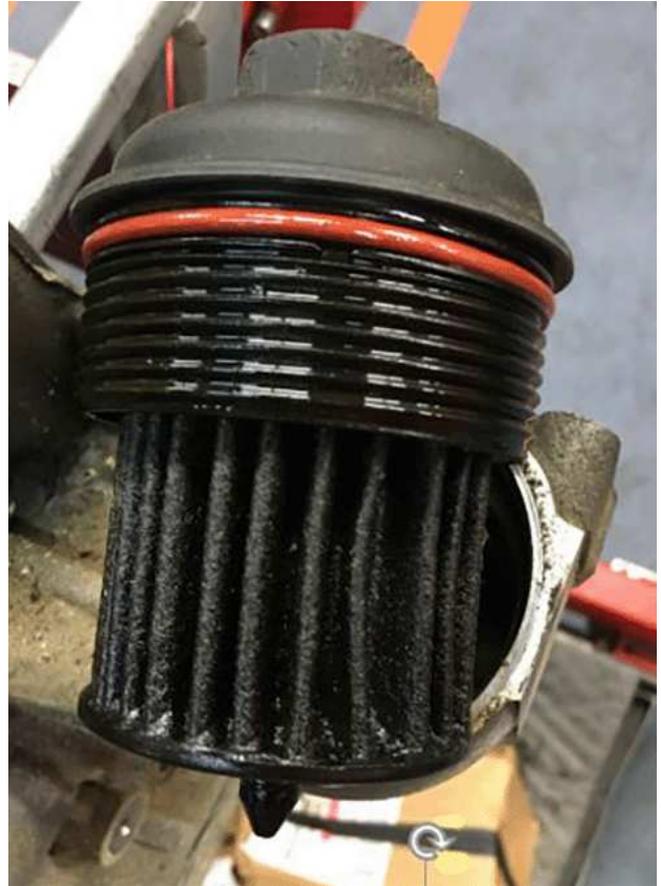
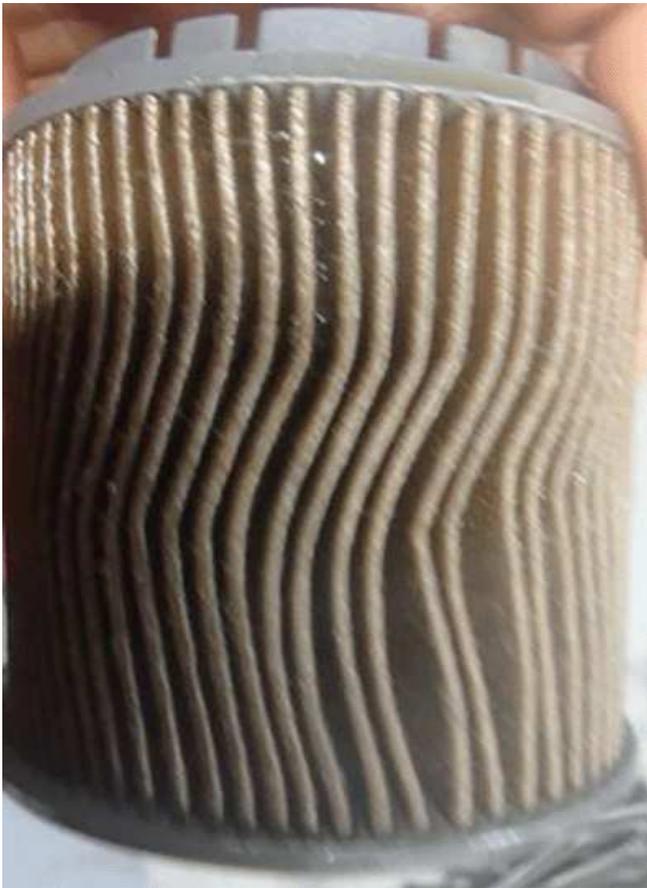
Shown are oil filter pleats with visible metal particles. In this example, minimal amounts of metal particles are visible on oil filter pleats and should not pose a concern.

If excessive amounts of metal particles are observed, or if there is evidence of damaged oil filter pleats, then unfiltered oil with bearing debris may have been pumped into the oil lubrication galleries throughout the engine. This will require further inspection to confirm the degree of contamination and appropriate repair direction. Refer to Service Bulletin #19-NA-256 for HFV6 Gen 1 and Gen 2.
